B IODETERIORATION OF HERITAGE BUILDINGS REPRESENTATIVE OF COSTA RICAN CARIBBEAN ARCHITECTURE

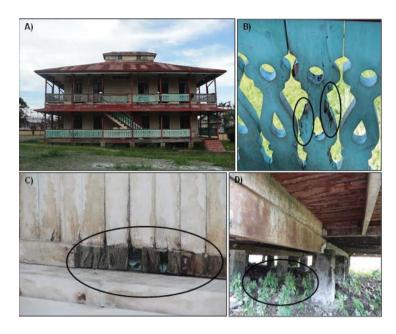
Structural damage such as loss of material, change in color, and presence of vegetation was also observed (Figure 3A-D). In the Antigua Capitanía de Puerto, 14 areas with damage caused by biological agents were identified, 79% of the areas that showed visible damage were caused by fungi, and 21% were caused by insects. Aesthetic damage such as a change in color and the presence of vegetation was also observed (Figure 4). In the Casa Misionera de la Iglesia Bautista a relative humidity of 87.4% and an average temperature of 25.5°C with a maximum of 32°C were recorded in one year. In the Antigua Capitanía de Puerto, an average of 25.7°C was recorded with a maximum of 34°C, and relative humidity of 87.34% was also recorded in one year.

Figure 3. Casa Misionera de la Iglesia Bautista (W - Type 1 - 01). A) Front view. B) Damage caused by insects (termites) (indicated with black circles). C) Damage caused by humidity and fungi (indicated with a black circle). D) Presence of vegetation under the structure (indicated with a black circle).

The outdoor structures constantly affected by humidity were more susceptible to damage (Figures 3 and 4) and there is a higher presence of fungi on the external surfaces than inside the structures.

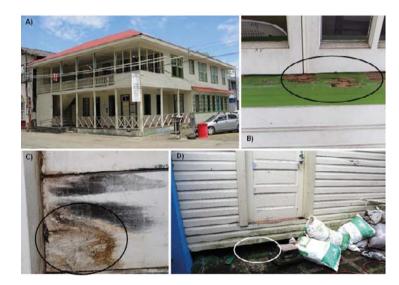
Figure 4. Antigua Capitanía de Puerto (AAA - Type 1 - 01). A) South and East view of the façade; B) Damage caused by insects (termites) (indicated with a black circle); C) Damage caused by humidity and fungi (indicated with a black circle). D) Presence of vegetation under the structure (indicated with a white circle).
