BIOTECHNOLOGY IN THE CONSERVATION FIELD: REMOVAL OF SULPHATES USING BACTERIA AND BIOCONSOLIDATION OF PAINTINGS AND STUCCOS

Keywords: bioconsolidation, biocleaning, bacteria, stucco, fresco

The aim of this study was to explore the use of biotechnologies in the restoration of wall paintings and stuccos which often show a great complexity regarding constitutive materials and conservative conditions. 'Biological methods' were compared to traditional methods, focusing on restoring the cohesion of the superficial layers (bioconsolidation) and the removal of sulphates (biocleaning) often found on the frescoes as decay products. The experimentation took place as part of a graduate thesis and was divided in two stages: the first was spent in the laboratory working on samples of painted plaster and the second was spent in situ, on the frescoes and stuccos in the Church of Santa Pudenziana in Rome, Italy. Application of the products was followed by a campaign of investigations aimed at determining the efficacy, and the advantages and disadvantages of these methods compared to conventional ones.

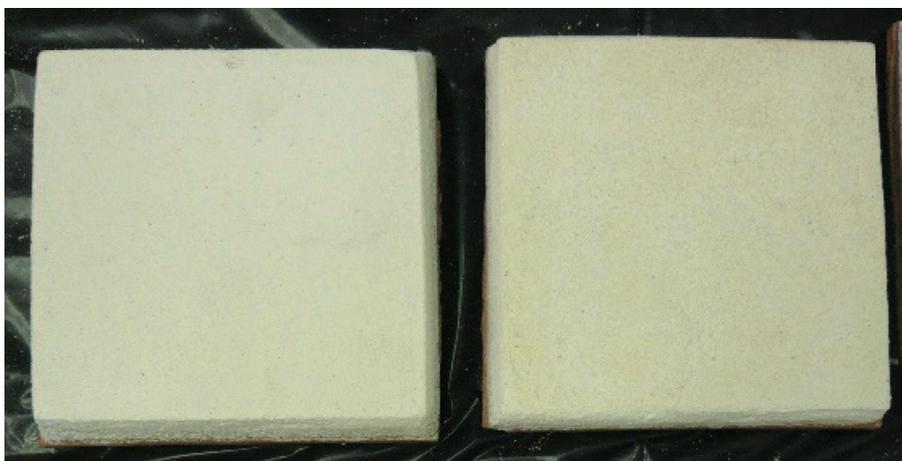
Figure 6. On the left the untreated stucco sample; on the right the sample treated with M-3P, slightly yellowed (Photo: Eleonora Panella).

Colorimetric measurements: on stucco samples treated with M-3P, colorimetric measurements showed a mild yellowing, while no remarkable variations were observed on the fresco samples (Figure 6). In addition, the surfaces treated in situ with M-3P did not show any relevant variation in colour.

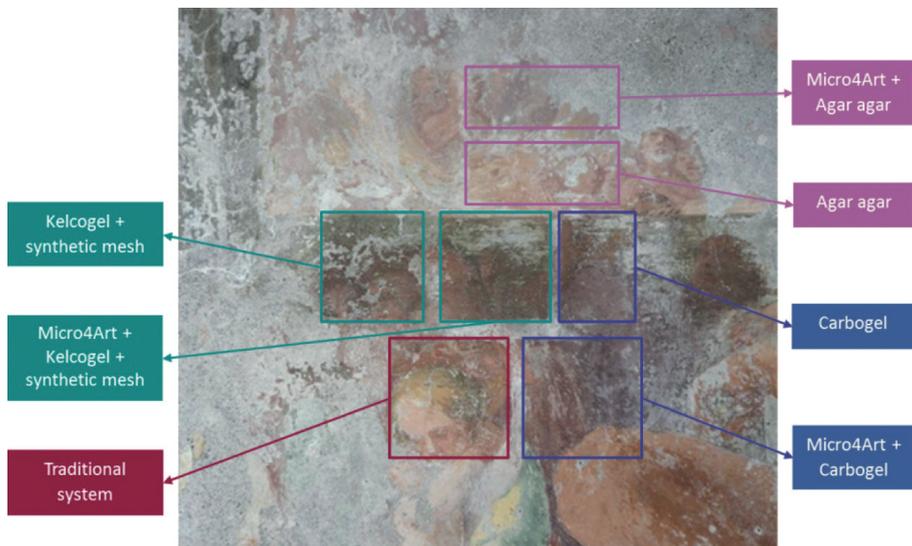
Figure 9. Test showing the different cleaning systems on the fresco surface (Photo: Eleonora Panella).

- a solution of 5% ammonium bicarbonate in deionized water gelled with hydroxypropyl cellulose⁸ and cellulose pulp (Figure 9).
