# **I BO ISLAND IN THE QUIRIMBAS ARCHIPELAGO: AN ARCHITECTURAL HERITAGE WITHIN A NATURAL HERITAGE**

***Maurizio Berti\****

*Keywords:* Ibo, Quirimbas, architectural heritage, natural heritage, coral stone

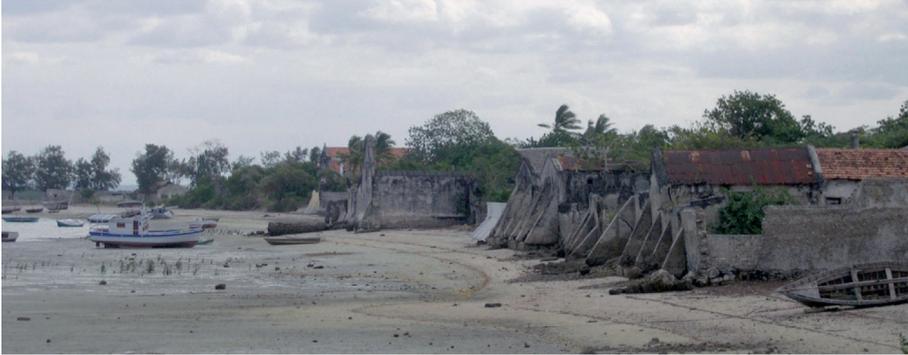
Figure 1. Porto Interior, Ibo Island. Porto Interior, Ibo Island. The buttresses prevent the collapse of the out-of-plane walls of the warehouses

The so-called Porto Interior is located on the west coast, with an entrance facing north. The west coast is characterised by deposits of sand and mud and, at the same time, is subject to the effects of tidal erosion. The harbour is the terminal part of one of the main tidal channels between the ocean and the lagoon, while on the opposite side there extends a large mangrove forest. Along the harbour, a wall with buttresses protects the island from tidal erosion (Figure 1).

Near the church, the quay is mostly occupied by old commercial houses with their moorings. The protective wall with buttresses is now at risk of collapse. In some places, the wall has completely disappeared, but the foundation base, made of hard square stones assembled with a strong binder, is still present.

The collapse of the harbour walls due to the action of the tide, necessitates immediate action. Low-intensity earthquakes have occurred in this area, but it

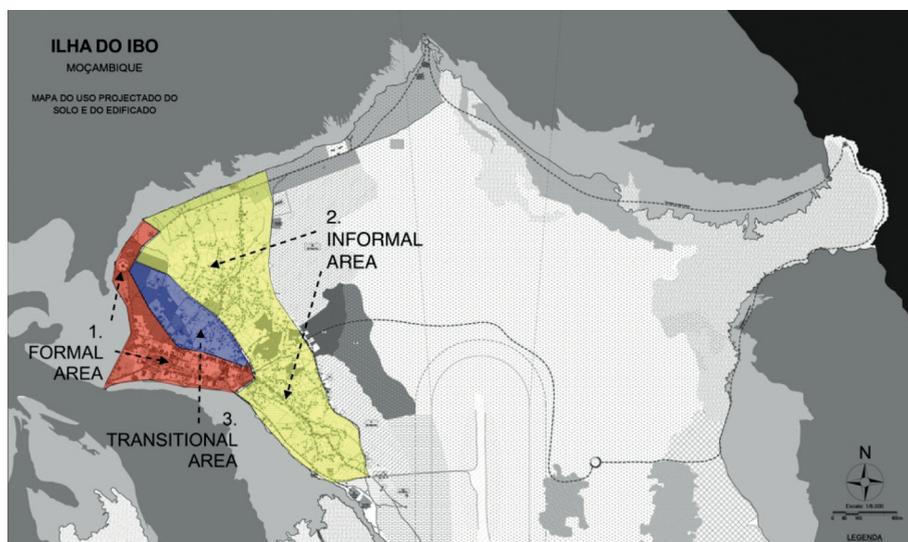
Figure 3. From the urban plan of the town of Ibo (2008): a re-working of the partial graphic map of the intended use of the soil and the settlement.

Revising the colonial division of two parts, the plan provides the creation of a third urban area in which to place the most useful infrastructures to improve life both in the formal and informal area. Consequently, the town is constituted by three large areas each with their own historical characteristics, namely: (i) the Formal Area, (ii) the Informal Area, (iii) the Transitional Area (Figure 3).

(i) The Formal Area, of approximately 23.3 ha, is made up of stone and lime constructions following a project and specific standards. A relatively small part of the population lives there. The Formal Area has an identifiable structure and the buildings have relatively homogeneous styles, presenting a clear overall unity. Formed by the most ancient and refined architecture, this area is largely abandoned, even though ownership transfers and the restoration of some buildings resumed in the late 1990s.

(ii) The Informal Area, of about 68.4 ha, has buildings made with stone and lime or structured with wooden poles (*pau-a-pique*), mostly covered with palm leaves (*macúti*), and is the result of a spontaneous process of occupation. More than 2500 inhabitants live in the area, the equivalent of about 75% of the island's population. The designation for this type of urban area is questionable. The informal settlement is, in most cases, the consequence of complex family processes in which the public authority is not always present. But this area shows great dynamism in social relations.

(iii) The Transitional Area, of about 13.6 ha, now establishes the interface between the Formal Area and the Informal Area, with constructions generally in stone and lime resulting from the recent expansion of the Formal Area, but without

The restoration of stone and lime houses in the Formal Area (Figure 3) is more problematic than that of the popular traditional houses in the Informal Area (Figure 3). In the first case, the community has been offered a choice between restoring or reconstructing. The island builders have lost the memory of the old colonial techniques and therefore more easily construct new buildings of little architectural value in place of the ruins of the colonial houses.

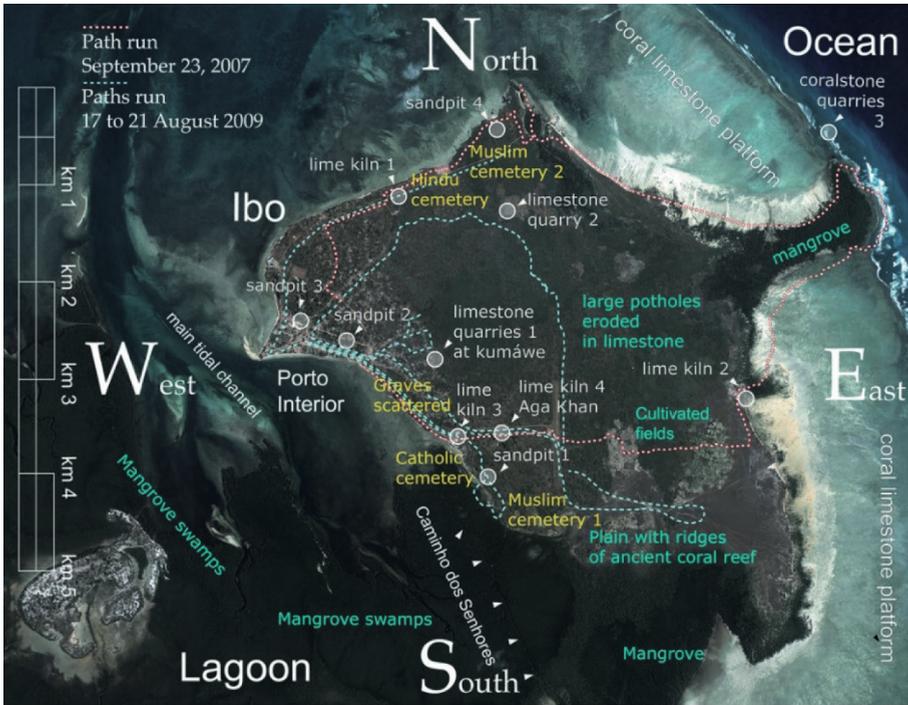
Figure 4. Field observations made by the author at Ibo Island during study visits. Paths drawn on Google Earth map, 2007-2019.

The surveys and discussions carried out during the three trips to the island of Ibo, two in 2007 (the second visit was made with the technical team in charge of developing Ibo's urban plan) and the last in 2009, indicated that the above simple arguments can help to interpret heritage as a combination of the natural and cultural systems (Figure 4).

Among the open lime kilns observed, some are cyclically activated, such as the two near the Catholic cemetery (Figure 8), while others have been found abandoned, as indicated on the 2007-2009 visit map (n.2, Figure 4) on the north-east coast.

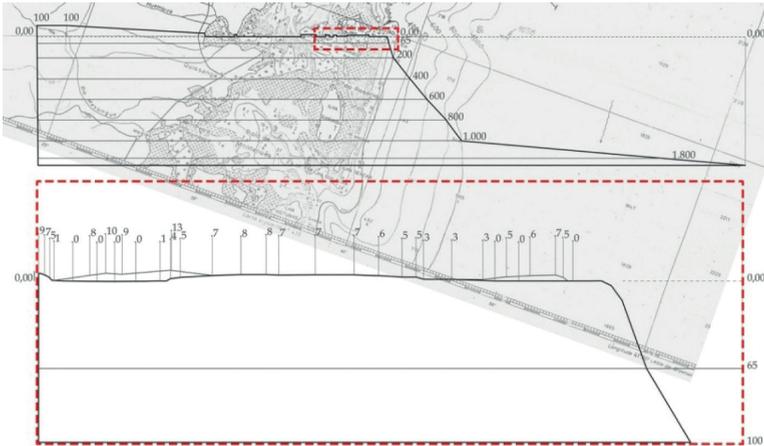
Figure 5. An extended section of the continental margin through Ibo. The hypothesis to be verified is the presence of a deep layer of fresh water from the mainland to the subsoil of the island.

The collection of existing studies on Ibo and the Quirimbas Island Park, as well as the related discussions suggest that knowledge of the hydrogeological conditions of the soil and subsoil is a prerequisite for any management plan. Considering that on the island there are about 150 non-drinkable water wells, with an average of 10 meters depth [8] and that the island is part of the continent's alluvial basin [9], it would be useful to check whether pristine waters could be drawn by drilling one or two wells in depth: this option would be a convenient alternative to an aqueduct that

brings drinking water from the mainland to the island through the lagoon (Figure 5). While on the one hand, the traditional practice of collecting seasonal rainwater in the cisterns remains valid, a 35m or 50m deep well for drinking water could qualify the town and if placed, for example in the Transitional Area (Figure 3), might determine a moderate urban density or a better placement of new buildings for public use, such as schools or markets [10-13]<sup>1</sup>.

<sup>1</sup> The extended section between the mainland and the continental edge on a track crossing Ibo, combines data from two maps: the Carta Hidrográfica da Foz do Rovuma ao Ibo of the Instituto Hidrográfico de Lisboa, 1965 (work copy by courtesy of Patricia Oberreuter) [14] and the Plano Topográfico base, hoja 1 e 2, 1997 in the Libro Blanco de los recursos naturales de la provincia de Cabo Delgado (Mozambique) – Agencia Española de Cooperación Internacional – Union Europea (copy at the Faculty of Arquitectura e Planeamiento Físico in Maputo) [12].

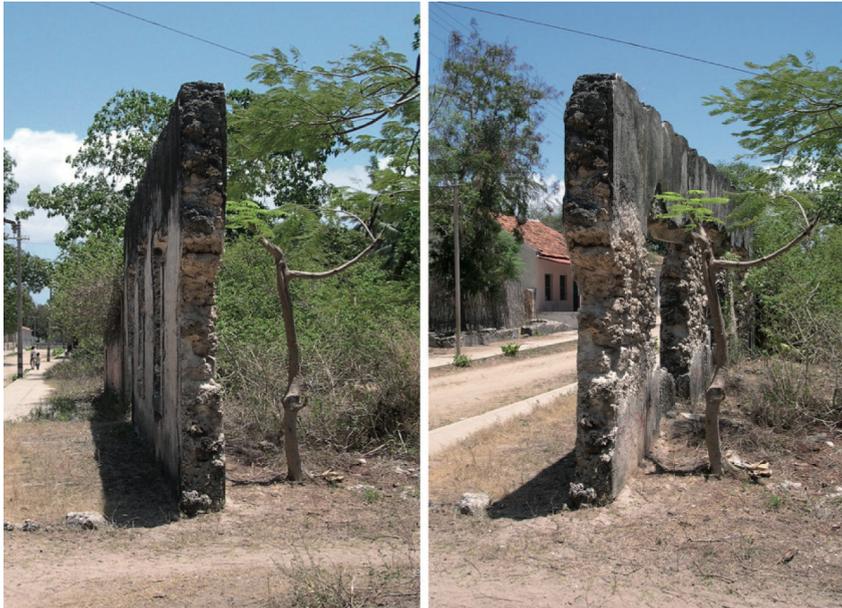
Figure 6. Wall in Rua Maria Pia. Observation of the phenomenon of disintegration where the different conservation state of the two sides (left and right) is evident and has been caused by the use of different plasters and exposure to sunlight.

Being as the process of rehabilitation of the architecture in stone and lime is very long, the owners of the historical architecture, whether uninhabited or in ruins, are obliged by the public administration to keep the property free from spontaneous vegetation to improve public hygiene and at the same time, preserve the architectural heritage. The vegetation that grows between the ruins does not protect them, for example from the sun or rain, but hides them, thus avoiding a visual inspection of the degradation: visual inspection is the first step in the procedure to preserve artefacts that are exposed to all kinds of conditions and climate (Figure 6).

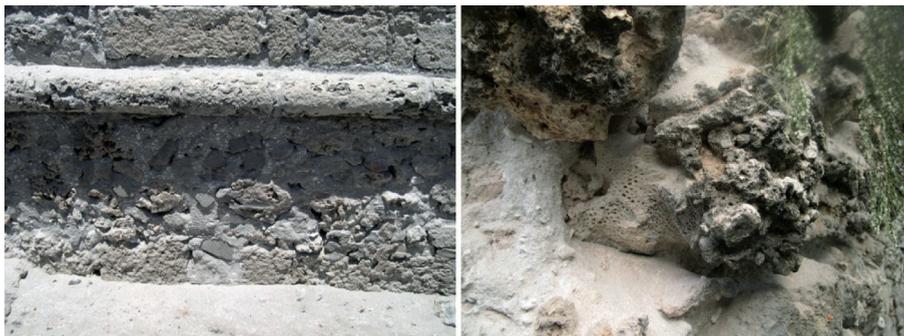
Figure 7. Left: consolidation tests on the Fortim de São José gate. Right: detail of the limestone disintegration in the ruins observed on the Rua Maria Pia.

Two interesting consolidation tests of the wall were observed on both sides of the *Fortim de São José* gate (Figure 7). The tests, carried out in 2005, had given a negative result: the lime mortar had not hardened, but gradually crumbled into dust at the foot of the wall. Performing the tests before the widespread application of the planned consolidation technique had been the right choice, as some errors were subsequently avoided when work was resumed two years later.

Through an empirical approach and observing test results, the island's population was able to learn about the construction technique used by the ancient Portuguese settlers and thus understand how it makes extensive use of the natural resources of their island. Knowledge of the construction system and availability of the building materials on site are two conditions that seem to guarantee the ordinary maintenance of the rehabilitated architectural heritage.

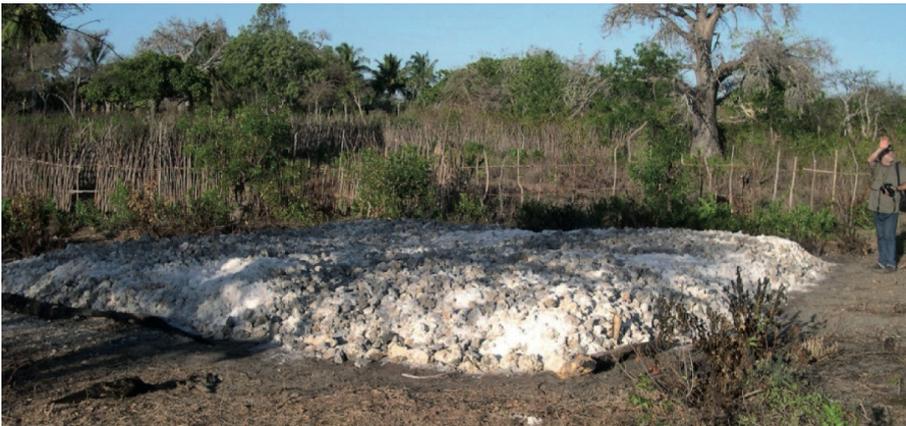
Figure 8. The lime kiln in the open air at the entrance to the Catholic cemetery.

The information collected and the direct testing of this kiln have given evidence of an artisan production for the market of Pemba, an important city on the continental coast about 100 km South of Ibo. The limestone to be cooked comes from different sites of the island and is chosen according to its intended use. A special case is the use of lime obtained from the calcination of the shells to whitewash the interior walls of the houses, making them more habitable because they reduce the perception of humidity in the rooms.

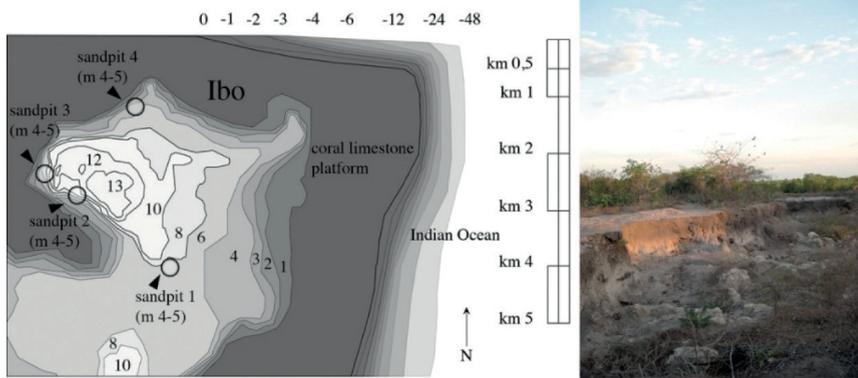
Figure 9. Sand site survey in Ibo. Sandpit n.1 on the map.

Other existing quarries were enlarged or new ones opened in areas outside the town for the many restoration yards that have been set up in recent years (Figure 9, left). It is curious to note that the two main ones are found near two cemeteries, a Hindu one to the North and a Muslim one to the South (Figure 9, right). This could suggest that there was a possible correlation between the excavation for the tombs and the discovery of river sand which was very suitable for mixing in a lime mortar.

Since it was easy to verify the siliceous or calcareous nature of the sand, three samples were taken from three different quarries. The test showed that the three samples were silica sand because they did not produce any chemical reaction during the experiment. When in contact with hydrochloric acid (HCl), silica sand stays in its state of physical integrity. On the contrary, when the calcareous sand comes in contact with the acid it reacts and releases carbon dioxide (CO<sub>2</sub>). This simple experiment shows that the continental sand deposits are found on the island itself and justifies the whole study when we try to correlate sea levels, coral reefs, and human settlements.
