THE RUPESTRIAN CHURCH OF SAN PIETRO DA MORRONE (MATERA, ITALY): INSIGHTS AND PHOTOGRAMMETRIC-BASED CHARACTERISATION

Keywords: rupestrian architecture, photogrammetry, geometrical characterisation, three-dimensional modelling

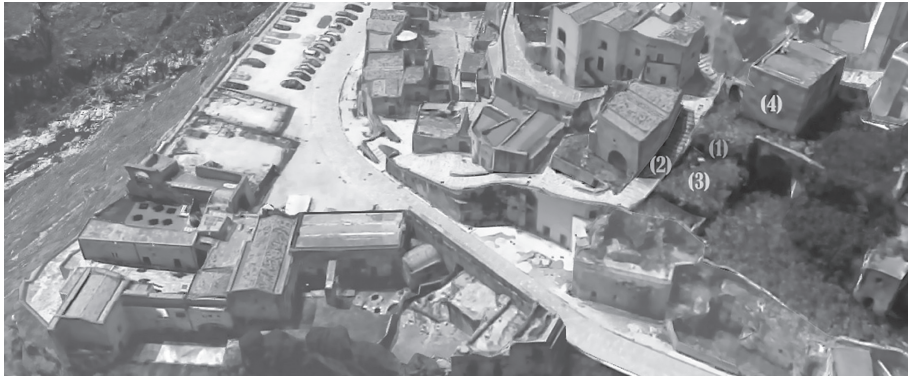
Figure 4. Oblique view showing the façade of the church (1), the access from Via San Potito (2), Via Civita (3) and the Palazzo de Vitis (4) (source: Image (Data SIO, NOAA, U. S. Navy, NGA, GEBCO) Google Earth ©).

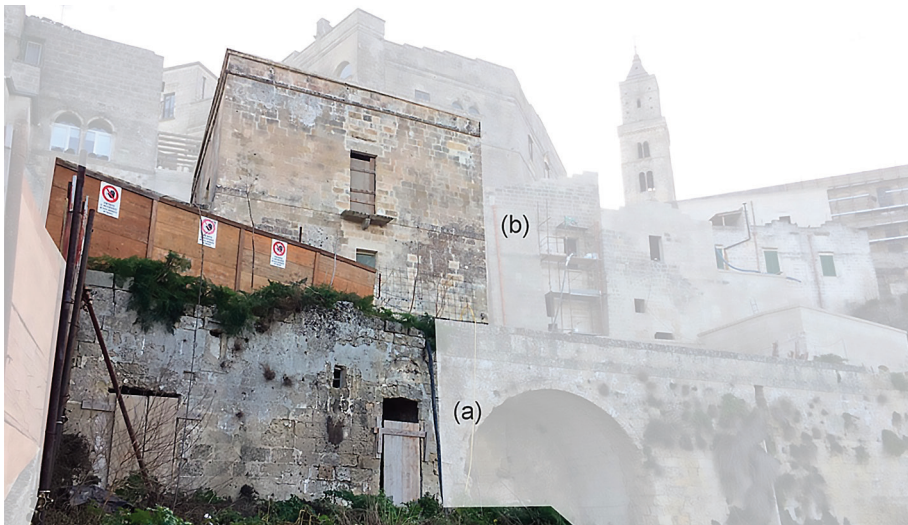
Figure 5. Image of the façade of the church (a) and its surrounding context, including Palazzo de Vitis (b).

As most of the rupestrian buildings in Matera, the geometry of the church is not only irregular in the distribution of spaces: the vaults and walls are geometrically complex. Furthermore, there are several structural reinforcements and additions to the original construction, such as masonry arches, that seem to have been added to the original vaults. Interventions of reinforcement may have been carried out because of the add-

ed weight when Palazzo de Vitis was built (Figure 5). The presence of these reinforcements and other modifications demonstrates the town's dynamics in adapting and continuously reconfiguring the urban environment.

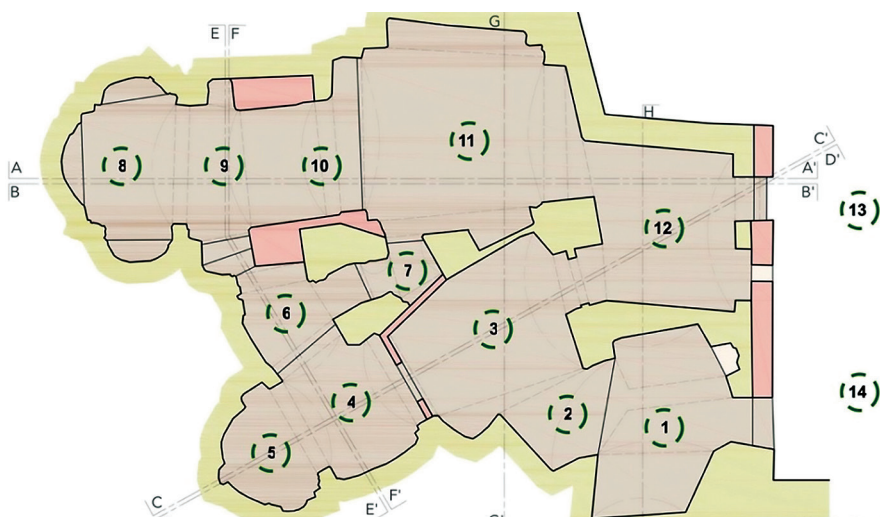
Figure 6. Planned route and stations. Each station corresponds to a spatial compartment of the construction.

The methodology for photographing the building started with a plan of the route to scan the walls and ceilings of the construction completely. A total of fourteen stations – corresponding to a total of twelve inner spaces and two exterior stations (Figure 6) – were proposed, based on a first on-site visual inspection and the sketches of the 1960 acts.

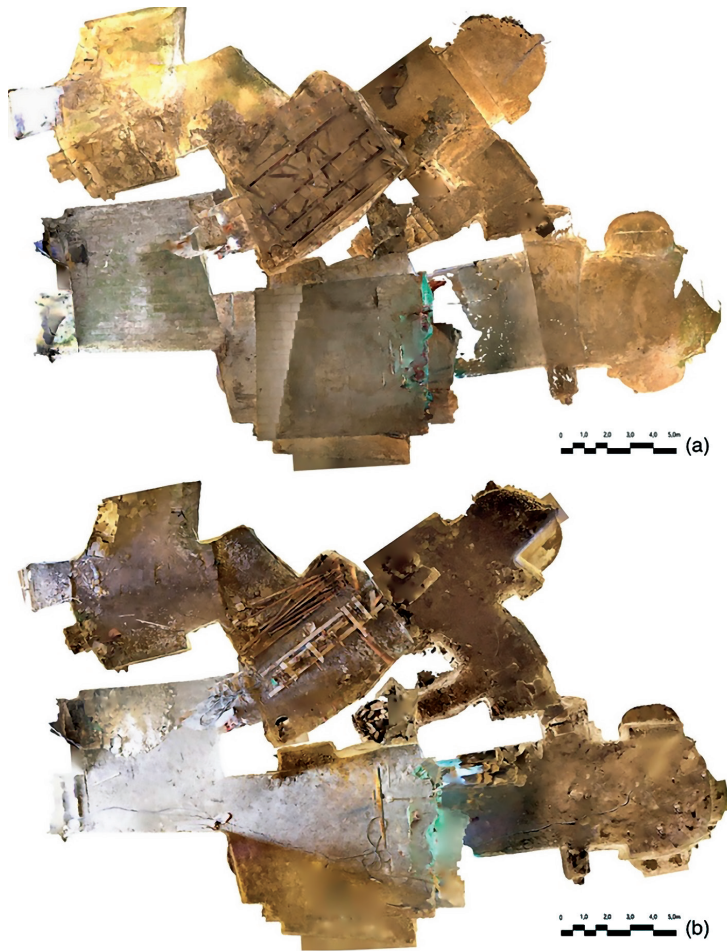
Figure 10. Photogrammetric reconstruction of the ceiling (a) and floor (b) plans.

Once the mesh has been obtained, it is possible to externally manage the model in numerous CAD platforms, such as Autodesk AutoCAD. Through simple volumetric operations it was possible to section the entire volumetry to obtain rectified photos for certain planes of interest. The orthophotos also permitted us to easily obtain a set of drawings to support the development of an architectonic project (Figure 10).

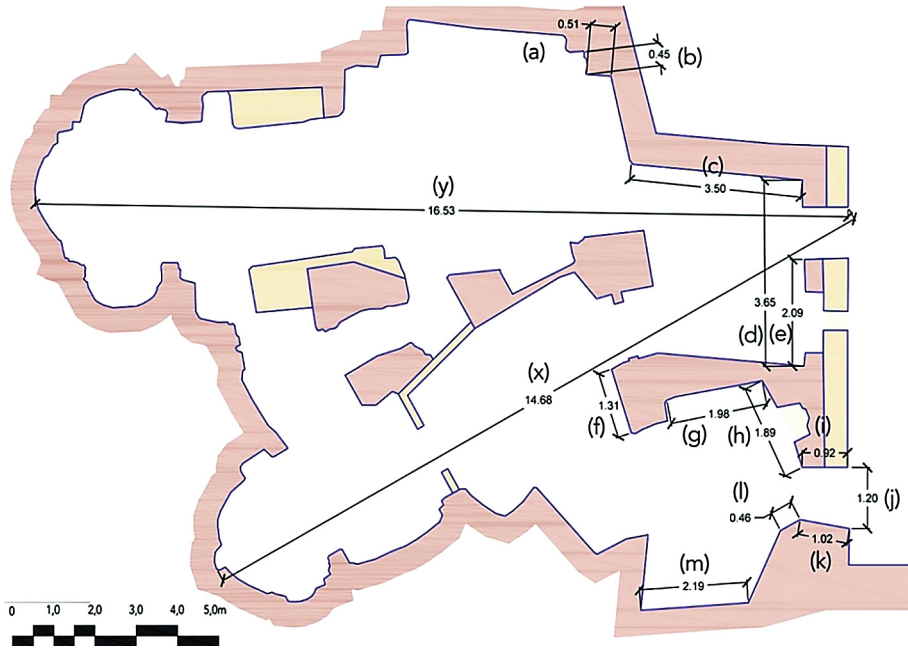
Figure 14. Selection of measurements obtained from the three-dimensional model.

A set of measures obtained from the model is shown in Figure 14. When comparing measures obtained on site against the ones provided by the model, no significant variations were identified, reaffirming the suitability of the model for describing the construction.

Table 1. Measurements obtained in-situ and from the model.

Measurement	Measurement from model (m)	Measurement with laser device (m)	Absolute difference (m)	Difference (% of laser meas.)
(a)	0.51	0.55	0.04	7.27
(b)	0.45	0.44	0.01	2.27
(c)	3.5	3.45	0.05	1.44
(d)	3.65	3.65	0.00	0.00
(e)	2.09	2.09	0.00	0.00
(f)	1.31	1.31	0.00	0.00
(g)	1.98	2.00	0.02	1.00
(h)	1.89	1.93	0.04	2.07
(i)	0.92	0.88	0.04	4.54
(j)	1.20	1.19	0.01	0.84
(k)	1.02	0.99	0.03	3.03
(l)	0.46	0.50	0.04	8.00
(m)	2.19	2.19	0.00	0.00
(x)	14.68	14.52	0.16	1.10
(y)	16.53	16.35	0.18	1.10
