COMMUNITY CULTURAL HERITAGE MANAGEMENT AND PROTECTION OF SELECTED MEDIEVAL ROCK-HEWN CHURCHES OF LALIBELA, ETHIOPIA

Yezihalem Sisay Takele*

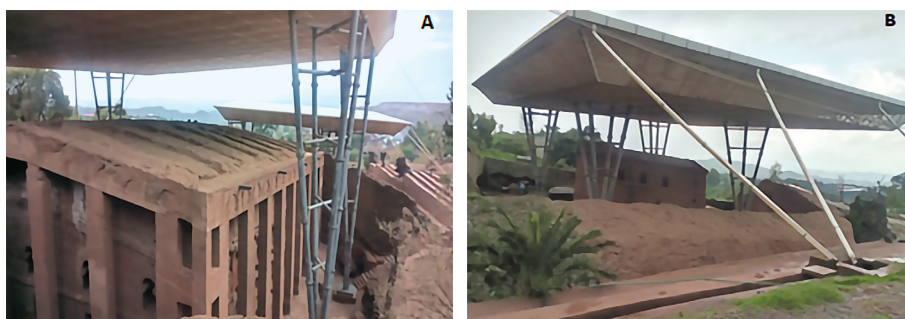
Figure 1. A) A canopy installed at the church of Bete-Medhane-Alem; B) the Bete-Mariyam Church with canopy.

The findings regarding the management practices of the Lalibela religious sculptures have identified serious concerns for their protection, as well as the fact that these management practices require further investigation. Since 2007, international organizations like the World Heritage Fund (WHF), UNESCO, and European Union (EU) have funded projects for the construction of canopies to protect five churches from the external elements. Yet, after doing so, a new problem arose when water began to infiltrate through the built canopies and caused further damage.

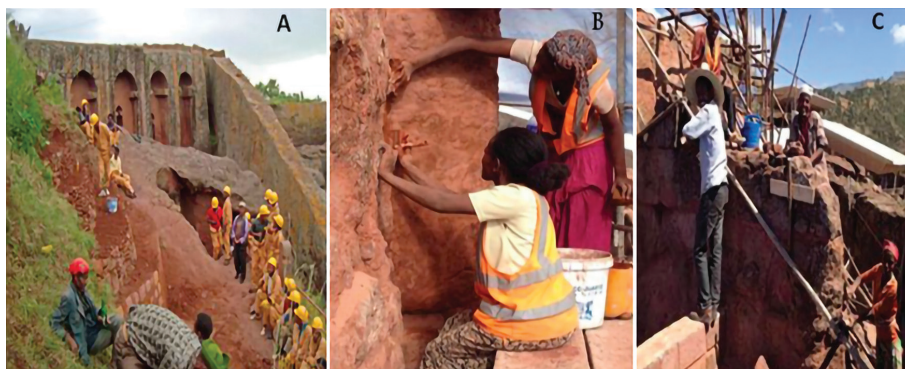
Figure 2. A) Local community involvement in a beautification project; B) cleaning decoration on the outside; C) conserving a damaged part of the heritage.

Yet the local community is still invited to public discussions to provide support for the cultural heritage management activities of the Church (Figure 2); consequently, the local community continues to participate in regular activities of beautification, clean-up campaigns, and environmental protection programs (Figures 2A, B and C). In evaluating the current situation of the WHS of the rock-hewn churches of Lalibela, it is clear that the structures are suffering from continuous threats. These threats can be divided into two main categories. First of all, general threats, which all the sites are facing, are related to the aging and erosion of the rock-cut churches, resulting in cracks. This process is supported by weathering agents such as water, acids, salts, plants, and temperature changes. Secondly, the threats are related to the weakness of national and regional heritage institutions' management techniques to conserve and maintain their long-term value.

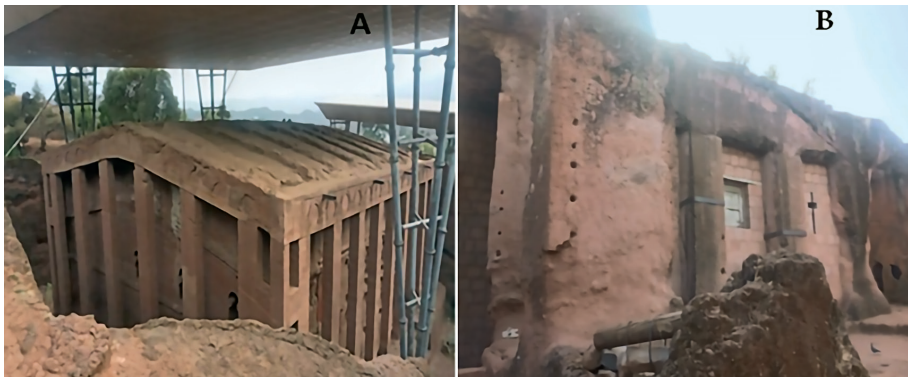
Figure 3. A) Bete-Medhane-Alem (House of the Savior of the World); B) Bete-Qeddus-Mercoreus (House of St. Mercoreos) Church.

The House of the Savior of the World or Bete-Medhane-Alem is the largest church of all and stands out due to its size. The large numbers of pillars of the church are considered pillars of great mystery. There are 72 pillars symbolizing the 72 disciples (34 inside and 38 outside) as shown in Figure 3A. The church is 11m high, 34m wide and 24m long.

The Church of Bete-Medehane-Alem (House of the Savior of the World) is a huge pink stone structure that was sculpted from the top down atop a rock cliff. It is the second work by Emperor Lalibela among the eleven churches and the widest and biggest of them all. Due to rainfall most of the roof is in a state of deterioration with poor conservation action [37]. Some of the pillars of Bete-Medehane-Alem church have been

rebuilt upon the original foundations after being damaged. The damaged pillars had to be rebuilt to protect those that were still standing. The external wall of the church also shows signs of deterioration, which is extending in different directions, a process which accelerated when water began to infiltrate through the built protective shades and resulted in further damage. In addition, one of the collapsed columns can still be seen abandoned, in a state of disrepair, at the north-western corner. There is a long crack inside the two church arcades. Inside the church, the walls are deteriorating due to water infiltration from the roof. The upper-row windows have round arches supported by brackets; the arches have ten small circular openings.

There are many passageways to this particular church and one subterranean flat dark hidden underground passage traditionally symbolizes hell. Likewise, the church itself symbolizes heaven. What is peculiar to this church is its monolithic altar, carved from the parent stone under it, with eight hewn pillars. The level of structural damage can be observed easily, and it is one of the most damaged and partially collapsed churches among the rock-hewn structures.

So far, it stands without any protective roof, and it has not undergone any preservation work. As a result of the partially collapsed structure, the church was unable to teach biblical doctrine for more than a decade to believers. The collapsed part of this church was repaired in the 1960s by an Italian conservationist called Angelini. It was then repaired again by local custodians in 1989. Since then, it has been used as a centre for worship.
