INTEGRATING CLOSE-RANGE PHOTOGRAMMETRY WITH DEEP LEARNING FOR INTELLIGENT 3D DOCUMENTATION OF CRACKS IN WIND-RAIN BRIDGE HERITAGE

To foster the in-depth application of real-scene 3D technology in architectural heritage conservation, this study focuses on the wind-rain bridges along the Xiao-He Ancient Road (China) and conducts research on a visualization method for apparent cracks based on real-scene 3D modeling. High-resolution images of the bridges were obtained through close-range photogrammetry, enabling the construction of a detailed real-scene 3D model. Using established algorithms such as DeepLabV3+ and YOLO, cracks in the architectural images of the wind-rain bridges were identified. Leveraging the multi-view overlap of the close-range images, the crack detection results from the deep learning algorithms were accurately located within the real-scene 3D model of the bridges. On this basis, the real-scene 3D model and the crack identification results were integrated into the Unity3D platform, achieving visualization of apparent cracks in the wind-rain bridge. The proposed method is directly applicable to heritage surveys, providing technical support for compiling digital arc

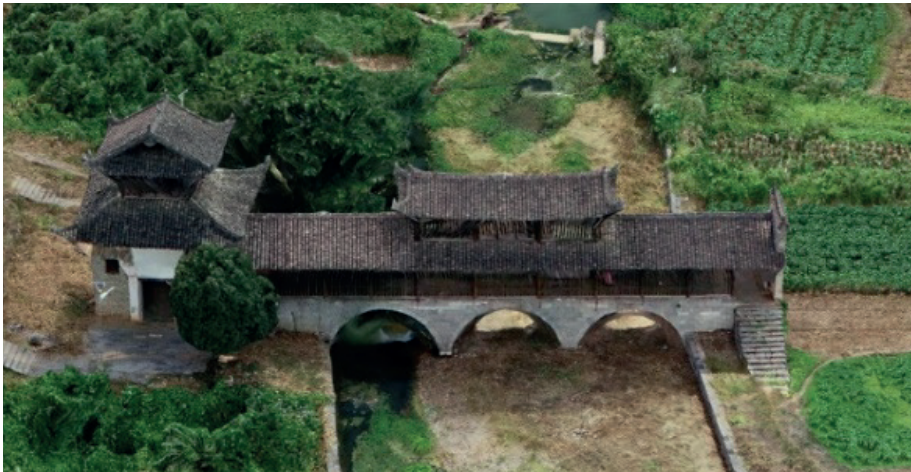
Figure 2. Aerial view of the Huilan wind-rain bridge

The Huilan Wind-Rain Bridge, a typical representative of the wind-rain bridge group along the Xiao-He Ancient Road, is located in Chaodong Town, Fuchuan County, Hezhou City, Guangxi. It spans the Huangsha River, connecting Youmu Village and Mulong Village. Constructed in 1602, the bridge features a corridor and pavilion with a depth of ten bays, a column-and-tie timber frame, and small blue-tile roofing. The entire structure is composed of a three-arch stone bridge, a bridge corridor, bridge pavilions, multi-story pavilions, and horse-head walls (Figure 2). The brick walls of the multi-story pavilions are decorated with multiple murals depicting figures, flowers, and birds. The four upturned eaves at the roof corners soar elegantly, and the ridge ornaments feature exquisitely crafted clay sculptures. The bridge largely retains its original appearance, possessing significant cultural value.

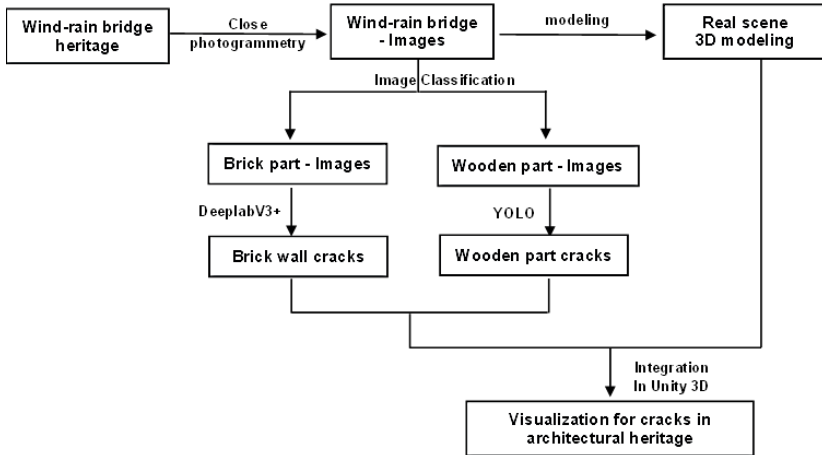
Figure 3. Technical pathway for apparent crack detection in wind-rain bridges.

The prolonged service life of the wind-rain bridge structures coupled with the cumulative effects of geological environmental changes, natural disasters, such as heavy rainfall and floods, and human-induced damage, has meant that the Fuchuan wind-rain bridge group has sustained varying degrees of damage. This includes the non-uniform settlement of the stone arch bridges, displacement of the horse-head walls, and weathering cracks in both the brick walls and wooden components. Therefore, it is necessary to conduct a comprehensive survey and statistical analysis of the current deterioration status of the wind-rain bridge structures. This entails constructing high-precision real-scene 3D models and integrating crack information and cause analysis within these models. The specific technical pathway is as follows: acquire building images through close-range photogrammetry; identify and mark cracks based on deep learning algorithms (using the DeeplabV3+ algorithm for brick wall crack identification and the YOLO_V5 algorithm for wooden component crack identification); map the identification results onto the real-scene 3D model for visual feedback; and present the research findings utilizing Unity3D software. The detailed technical workflow is shown in Figure 3. This method can effectively promote the in-depth application of real-scene 3D models in cultural heritage surveys and digital preservation.

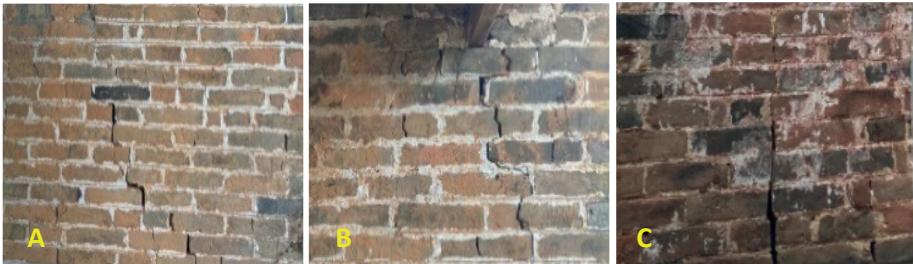
Figure 4. Images of the cracks in the horse-head wall of the wind-rain bridge. (A) Crack area 1; (B) crack area 2; (C) crack area 3.

The wind-rain bridges along the Xiao-He Ancient Road have a history of several hundred years. The cracks in their horse-head wall brick masonry structures are already mature, and the crack widths are relatively noticeable. Immature cracks only exist on the surface of the brick walls without penetrating through and have minimal impact on the structural stability of the brick walls. Therefore, this study marks the outer contours of the brick wall cracks in the building images and employs a method of widening the annotated cracks in the brick wall images. The DeepLabv3+ deep learning algorithm was used to train the brick wall structure image dataset from the Xiao-He Ancient Road area. Comparing the training results with the manually annotated data showed that the accuracy of DeepLabv3+ in identifying brick wall cracks reached 96%. The trained DeepLabv3+ algorithm was then used to identify cracks in the horse-head wall structures of the wind-rain bridges in the Xiao-He Ancient Road area (as shown in Figure 4). The results of the identification are shown in Figure 5. To highlight the crack identification results, the brick wall images are set to black, and the cracks are set to white.

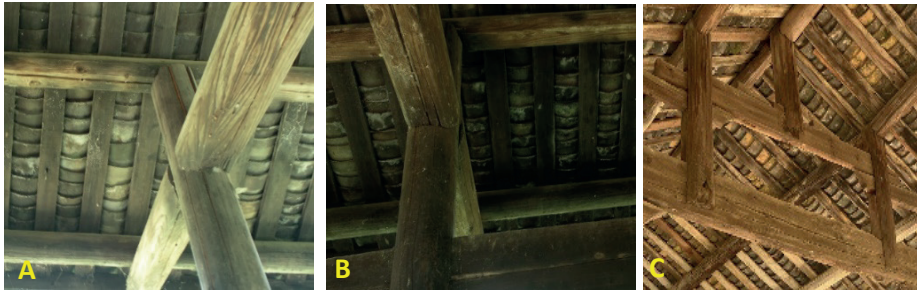
Figure 6. Images of cracks in the timber structure of the wind-rain bridge. (A) Crack zone 1; (B) crack zone 2; (C) crack zone 3.

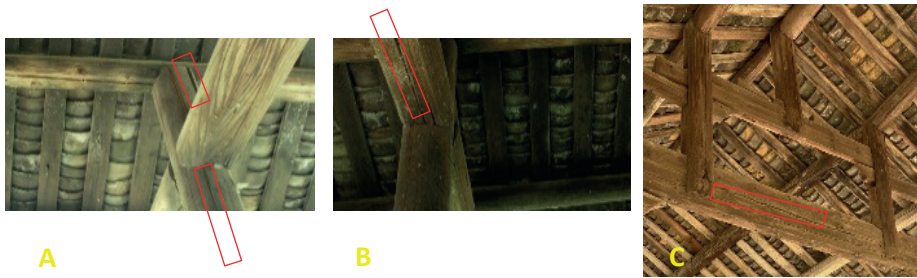
Figure 7. Images of cracks in the timber structure of the wind-rain bridge. (A) Crack identification 1; (B) crack identification 2; (C) crack identification 3.

Based on the results obtained using YOLO_V5 to identify the cracks in the timber structure, it can be concluded that the cracks in the timber structures of the wind-rain bridges along the Xiao-He Ancient Road primarily develop longitudinally along the timber members and are mainly found at the mortise-tenon connections between components. The main reasons for the formation of these cracks are that the machining process at the mortise-tenon joints damages the continuity and integrity of the timber member in the longitudinal direction. Additionally, the mortise-tenon connection points are subjected to the highest stresses relative to the entire member.

The performance of the trained YOLO_V5 model was evaluated on a separate test set. It achieved a precision of 92.5%, a recall of 88.1%, and a mean Average Precision of 89.4%, demonstrating capability in locating cracks in the timber structures. After completing the training on the images of the cracks in the timber structures from the Xiao-He Ancient Road area, the images obtained via close-range photogrammetry of the wind-rain bridge (Figure 6) were used for testing. The structural timber components are free from surface coatings, such as paint or plaster, thus minimizing potential interference with the YOLO_V5 algorithm's ability to detect cracks in the timber structure. The test results applying the YOLO_V5 algorithm to the timber structure are shown in Figure 7.

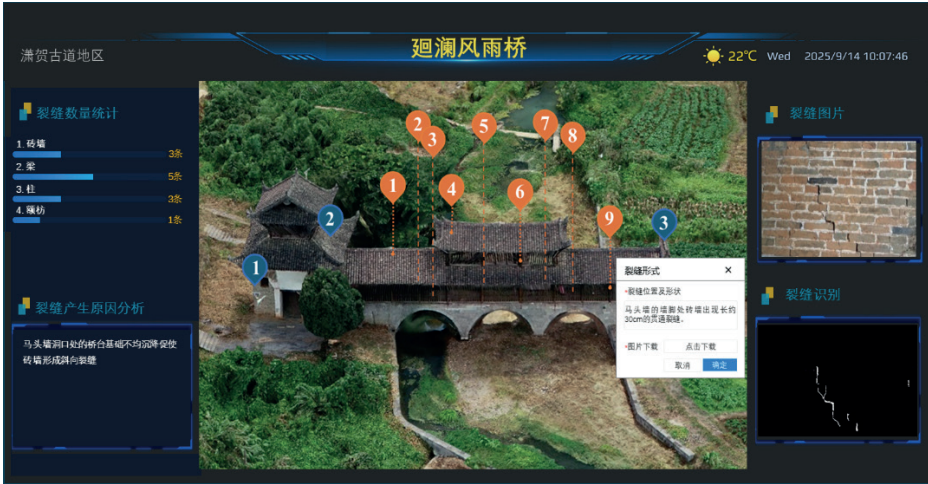
Figure 8. Visualization platform for apparent crack detection of the wind-rain bridge.

In Figure 8, the blue markers locate cracks in the brick-concrete structure, while the orange markers locate cracks in the timber structure. Dialog boxes are set at these marker points. The content of these dialog boxes describes the crack's shape, dimensions, and location, and allows for downloading images of the crack identification results. This serves as a digital archive of the apparent crack detection results for the wind-rain bridges along the Xiao-He Ancient Road. Hovering the mouse over a marker point, an information window pops up displaying details about the crack form. Clicking on a marker point directly switches the perspective to the crack location at that point, enabling intuitive observation of the relationship between the crack and the surrounding structure. Within the Unity3D software, users can freely navigate the real-scene 3D model to view the crack patterns. Staff from cultural relic protection units can intuitively observe the real-scene 3D model of the Xiao-He Ancient Road wind-rain bridge and its apparent crack characteristics, allowing them to accurately assess the service performance of the bridge.

After importing the real-scene 3D model into Unity3D, the collected images of the wind-rain bridge structure were categorized into two main types: timber structure and brick-concrete structure. The trained DeepLabV3+ and YOLO algorithms from this study were then used respectively to identify cracks in the timber structure and brick-concrete structure images. The identified crack images were simultaneously located and imported into the Unity3D software and mapped onto the surface of the real-scene 3D model. Trigger points for locating the cracks in the images were set within Unity3D, forming a visualization platform for detecting apparent cracks in the Xiao-He Ancient Road wind-rain bridge structure, as detailed in Figure 8.
