THE MUQARNAS CEILING OF THE PALATINA CHAPEL IN PALERMO

Giovanni Fatta*, **Tiziana Campisi**, **Mario Li Castri**, **Giuseppe Costa**
Dipartimento di Architettura (d'ARCH)
Università di Palermo, Italy

Keywords: wooden structures, *muqarnas*, ceiling

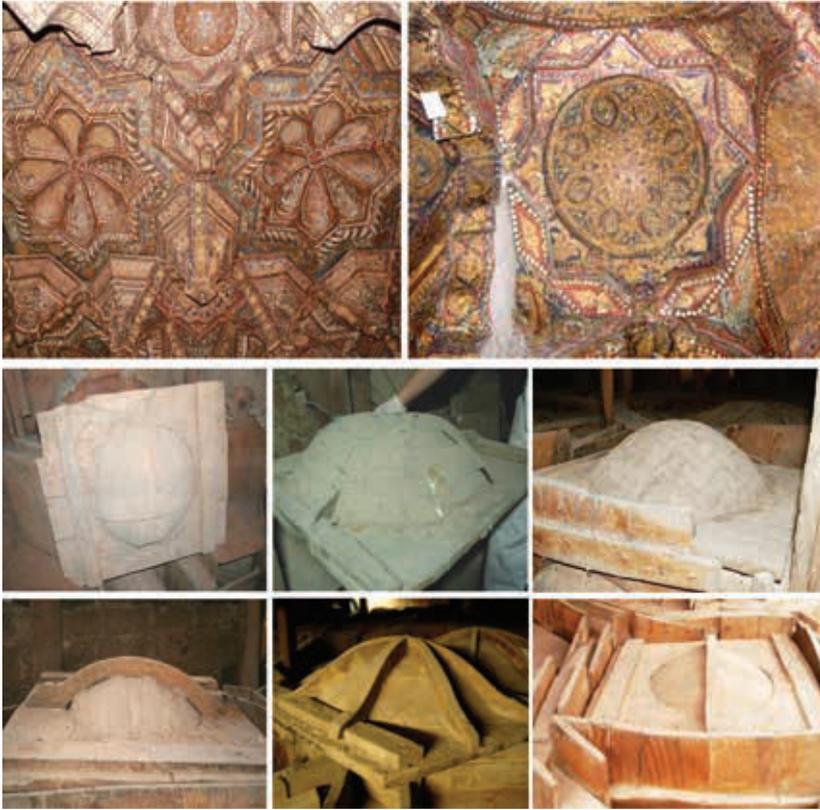
Figure 7. Top: intrados views of multi-lobed star on octagonal support and star-shaped module of a cupoletta. Bottom: different construction systems used for the cupolettas.

c) The little *cupolettas*, with pictorial decoration of a mainly geometric and non-figurative type, are set in the middle of a flat cover-panel on a square base; this too was made with planks placed side by side and nailed on to other transversal planks. The *cupolettas* have a base measuring about 50 cm per side and a rise of about 20 cm. At the vertices of the quadrangular hole, on which the cover-panel with the *cupoletta* rests, there are diagonal fillets hidden on the intrados that provide a triangular support for the vertices of the cover. Only the central part of this decorative module, corresponding to the *cupoletta* and to the perimetric 8-pointed decorative band, was built off-site. After being completed and finished, it was placed on the fixed part of the perimeter characterized by a star-shaped hole. The *cupoletta* structure presents several construction variables: some have ribs jutting out from the extrados and the dome shape, produced using steam and/or wet curved veneers nailed to the actual ribs of the intrados, then stiffened with strips of pasted-on lint wood. Others include a structure with wooden strips positioned in different directions or a structure with a device consisting of small veneer rectangles applied in several layers with staggered joints, which perhaps made it easier to obtain the desired curvature. Along the edges of the lacunars, created to accommodate the mobile ornamental modules, the rustic planks were left to jut out from the extrados so as to keep the cover-panels firmly in place, preventing the lateral portions with no decoration from remaining exposed (Figure 7).

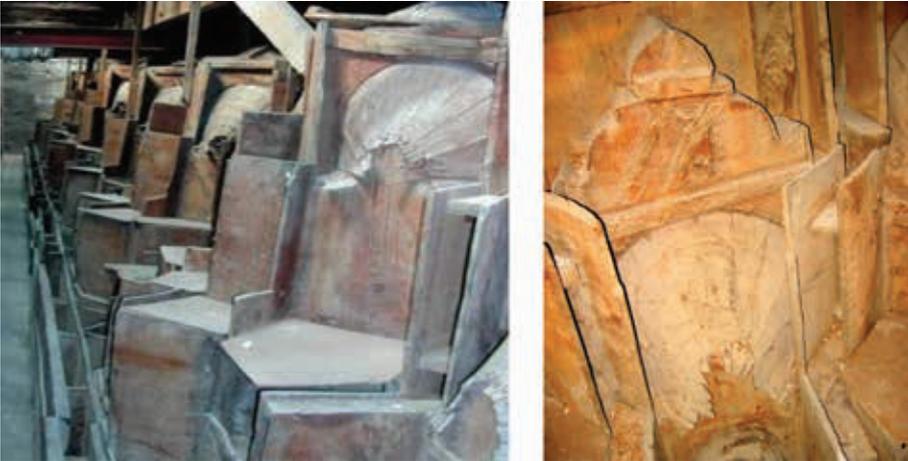
Figure 9. Construction details of decorative elements in the muqarnas registers.

wood-fibre and glue. In similar fashion, the elongated niches were given a barrel roof shape and those that constituted the brackets, a “cavetto” profile, useful for linking up the honeycomb decoration with the central portion of the ceiling, creating the characteristic steep progression of the projections (Figure 9).

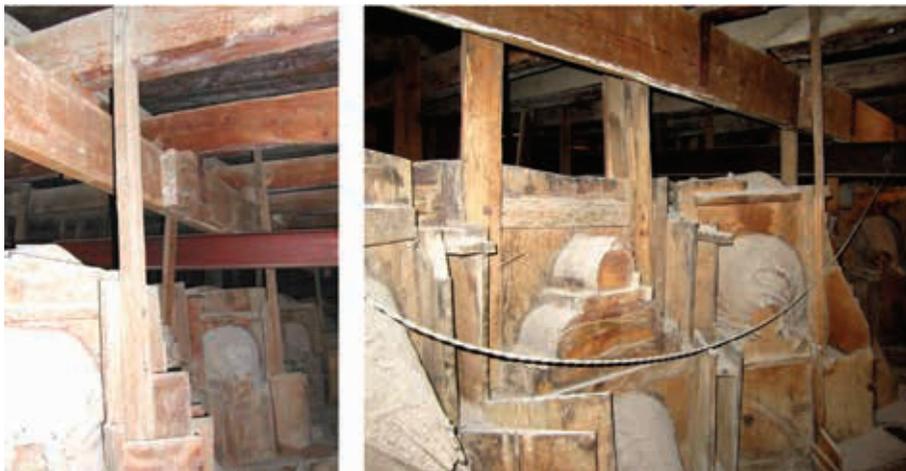
Figure 10. Wooden plank hanging supports connected to overlying structures and support beams for the ceiling, made of iron and wooden beams.

The wooden hanging units are connected to the stringers and the beams; they are simple laths with an average section of about 3 cm x 8 cm and a variable length of between 70 cm -160 cm. In all there are 174, of which 114 are nailed to the system of semi-square beams and 60 to the longitudinal stringers. The connection is made on the long side of the section of the “hanging unit” as well as on the short side. In the latter case the lath often has a cavity which reduces the section. It has a regular and sub-vertical shape in the flat part of the ceiling and is slightly inclined when it lies along the perimetral strip of the ceiling [8, 9] (Figure 10).
