USE AND EFFICACY OF THERMOGRAPHY FOR STRATIGRAPHIC ANALYSIS OF HISTORICAL BUILDINGS

Keywords: thermography, historical buildings, stratigraphic analysis, restoration

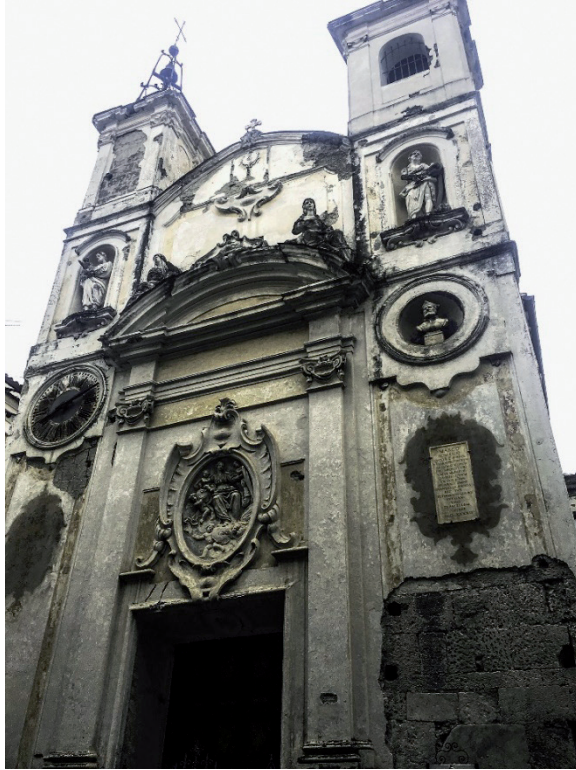
Figure 2. Sessa Aurunca (Caserta), Church of San Giovanni in Piazza. View of the façade on Corso Lucilio, highlighting the mediocre state of conservation of the finishings (photo: Francesco Miraglia).

The inspiration for the research project was provided by the removal of a portion of plaster from the Church of San Giovanni in Piazza (Figures 1-3), which cast light on a construction technique where recovered stone blocks were used as well as on the use of a corner column.

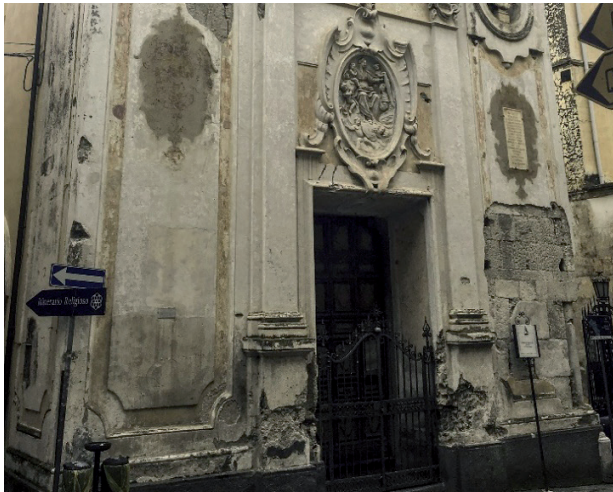
Figure 3. Sessa Aurunca (Caserta), Church of San Giovanni in Piazza. The base object of the thermographic investigation. The portion on the left is substantially intact, although marked by evident decay of the material; the portion on the right highlights a large gap in the plaster (photo: Francesco Miraglia).

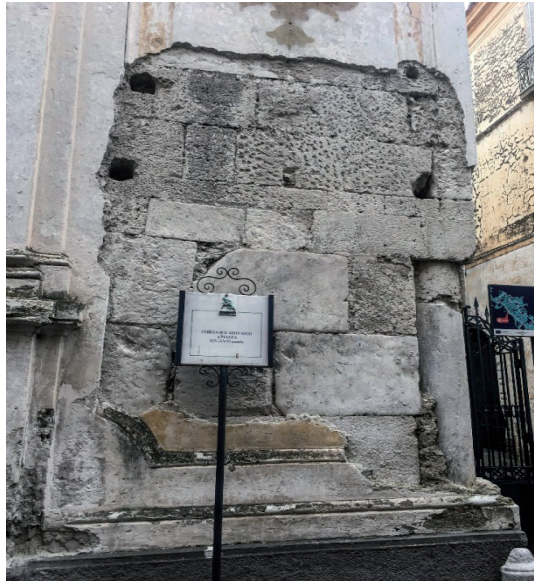
Figure 4. Sessa Aurunca (Caserta), Church of San Giovanni in Piazza. The portion of façade (right side) is useful for understanding the revealed masonry composed of blocks of reused limestone with a corner column and superimposed rows of ashlars making use of grey Campanian tuff (photo: Cesare Crova).

At about five metres above the road level, the second phase in the construction of the Church (Figures 4-5) was visible, as ashlar of local grey tuff were used which, also in this case, can be observed in a gap in the plaster of the upper portion of the façade, revealing the masonry above (C.C.).

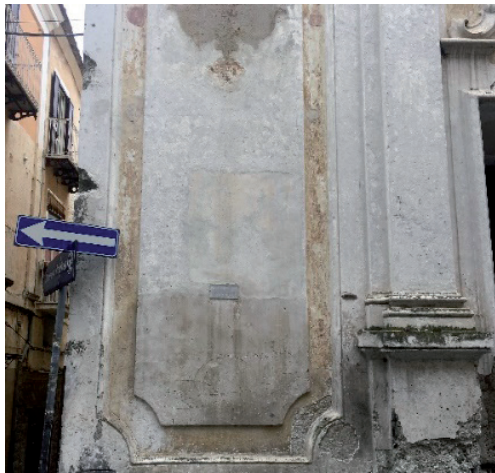
Figure 5. Sessa Aurunca (Caserta), Church of San Giovanni in Piazza. The portion of façade (left side), does not show any useful elements for understanding the characterization of the masonry (photo: Cesare Crova).
